COUNTY ADMINISTRATOR'S OFFICE

Re: New information: Rosemont Copper Mine, Section 404 Clean Water Act

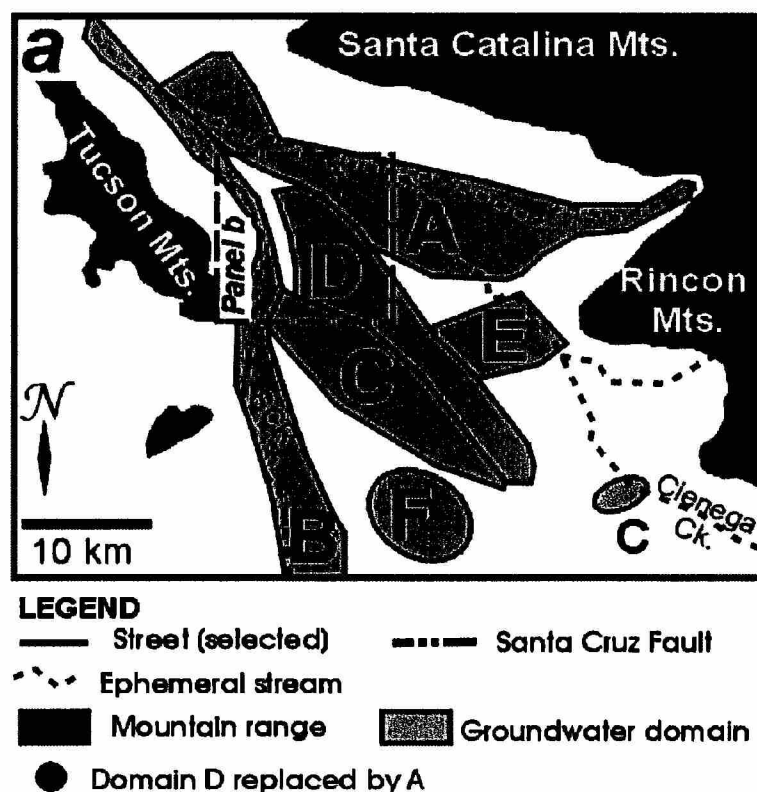
Figure 1. Reproduction from Figure 5 of Eastoe and Gu (2016) showing the contribution of water from Cienega Creek (noted by "C" on the map) to groundwater under Tucson and Vail.

A new publication (Eastoe and Gu 2016; (Attachment 1A) documents that the groundwater under Tucson originated from the Cienega Creek watershed. Water derived from Cienega Creek can be identified in the groundwater by the chemical signature of Permian marine sulfates that are not present in the Tucson Basin. Figure 1 below shows the spatial extent of the aquifer affected by recharge from this watershed. It extends from the Vail area to The University of Arizona campus and further down-gradient into downtown Tucson. Thus, the risks of waterborne pollutants

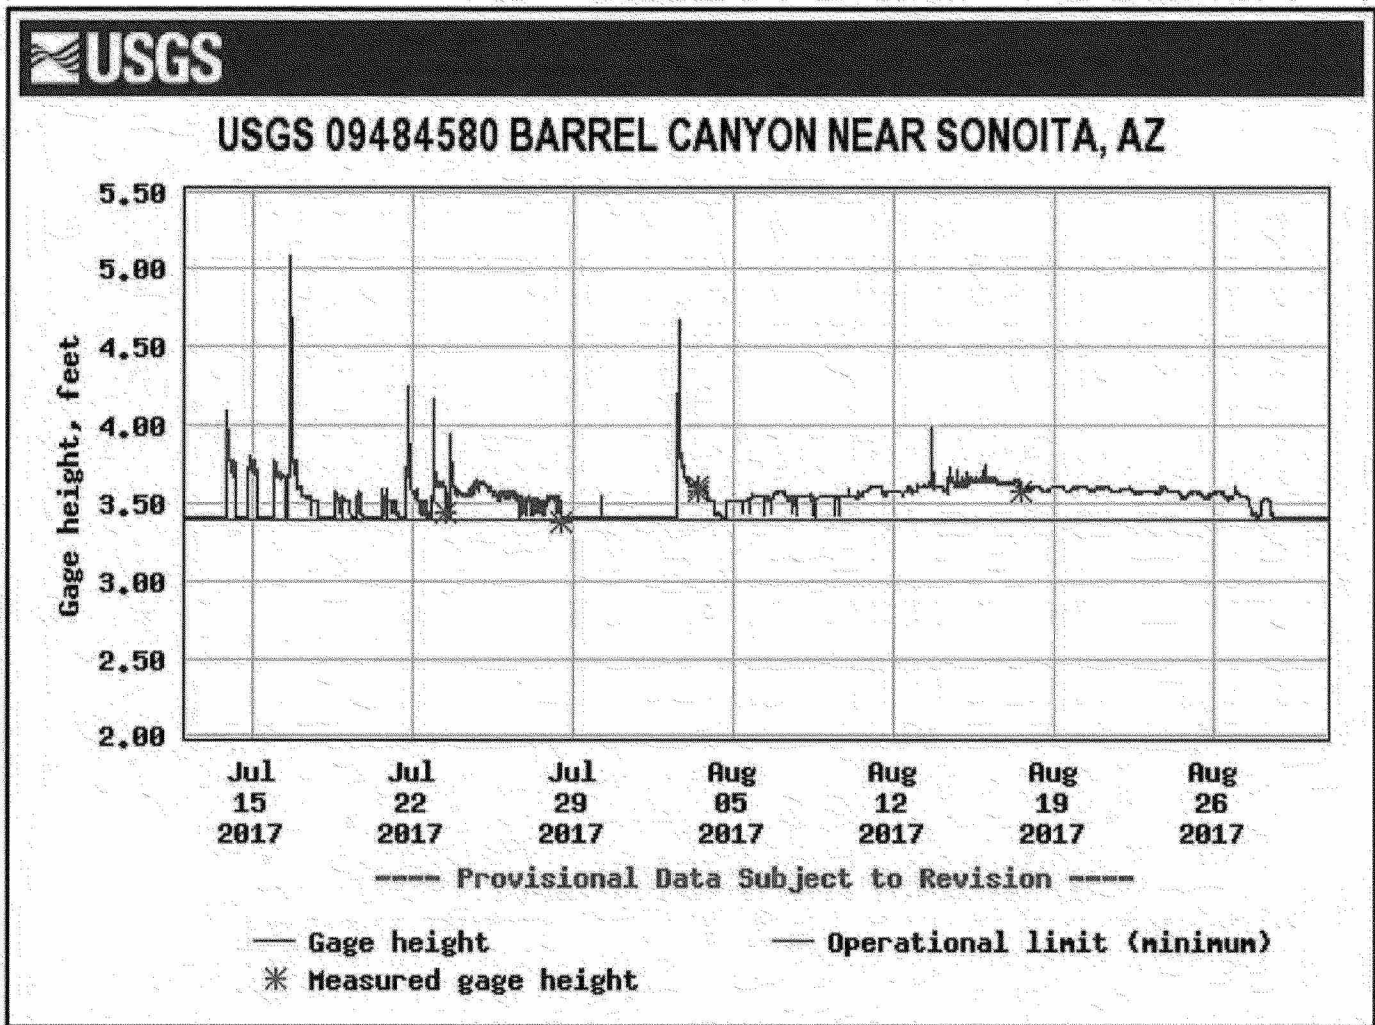
Figure 3. Peak and base flows in July and August 2017 at USGS Gage 09484580. Base flows persisted long after the last measured rain at the gage (August 3, August 15).

In recent years, the USGS has more thoroughly identified the frequency, magnitude and duration of flows at USGS Gage #09484580, located at a culvert under Highway 83, upstream of "Barrel Spring" (Figure 3). The gage is located at a point within the PAG-mapped intermittent flow reach. USGS staff periodically visit the stream gage to perform maintenance and rate the accuracy of flow measurements. During visits, USGS documents actual stream flow conditions using direct measurement of flow and visual observations.

The table in Attachment 5 shows the days since last rain when USGS documented flows using field observation. The record shows recent events where base flows persisted as long as 14 days after rainfall (January 25, 2016). This monsoon, there were two periods with base flows for a number of consecutive days in July and August, which are shown in the graph below. Red Xs indicate the date of field observations at the gage by USGS personnel. Storm flows are shown by the sharp rises with a "tail," and the base flows by the relatively stable low flows in between the peaks.

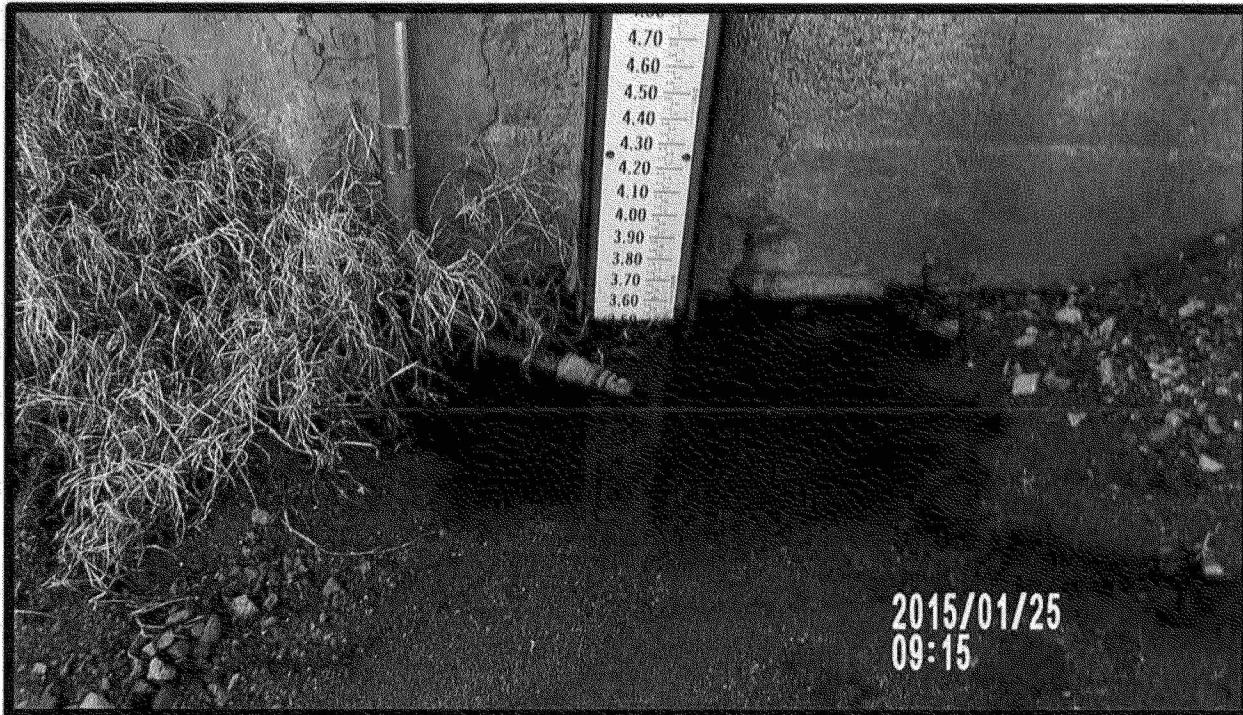
Figure 4. Algae in water around the pressure transducer at the Barrel gage. Algae is not found in ephemeral systems, but rather is typical of intermittent and perennial streams. Also note that the base flow is clear and very small in comparison to storm flows. The most recent rainfall (0.01 inch) at this site fell on January 16, 2016. The actual photo date is 2016/01/25, based on the field data sheet, camera metadata and confirmation with USGS (Attachment 5). USGS photograph.

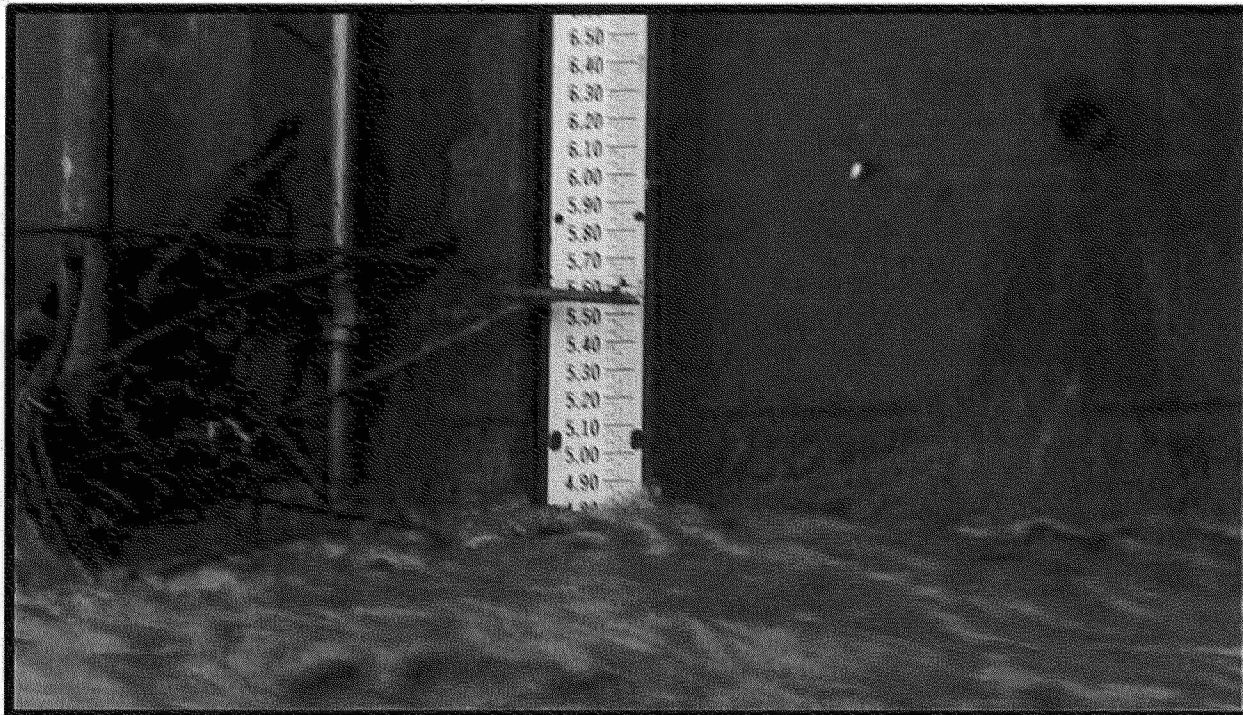
Figure 5. Flood flow taken by U. S. Geological Survey at the same location from September 11, 2013, 2:48 p.m. Note the higher elevation of the flow on the staff gage and the turbidity of the stormwater.

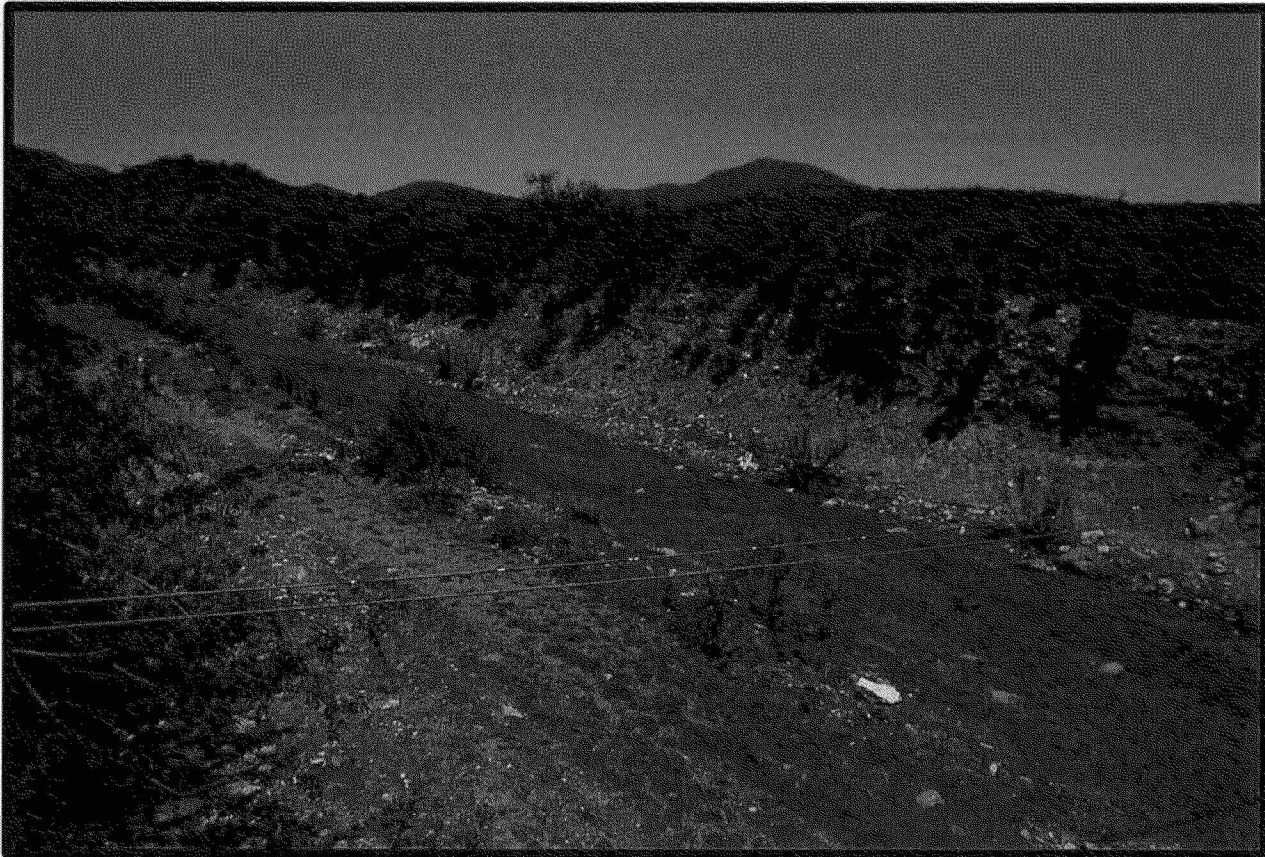
Figure 6. This photograph, taken from the culvert and looking upstream of the gage on August 16, 2017, shows intermittent stream flow and numerous hoof prints in moist sand from livestock use.

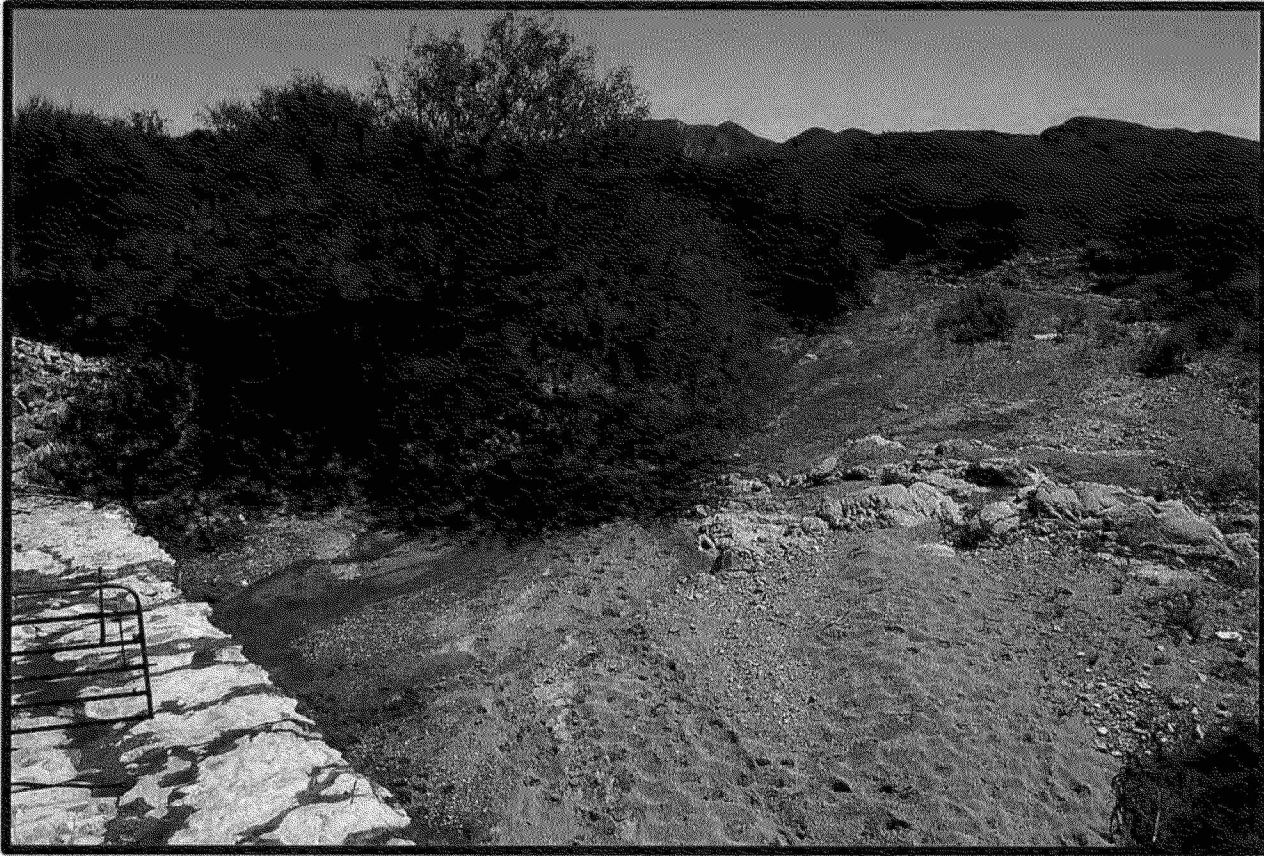
Figure 7. This photo (same date as Figure 6), shows flow continuing downstream across bedrock exposures. A gate under the culvert can be opened to allow livestock to move safely under Highway 83.

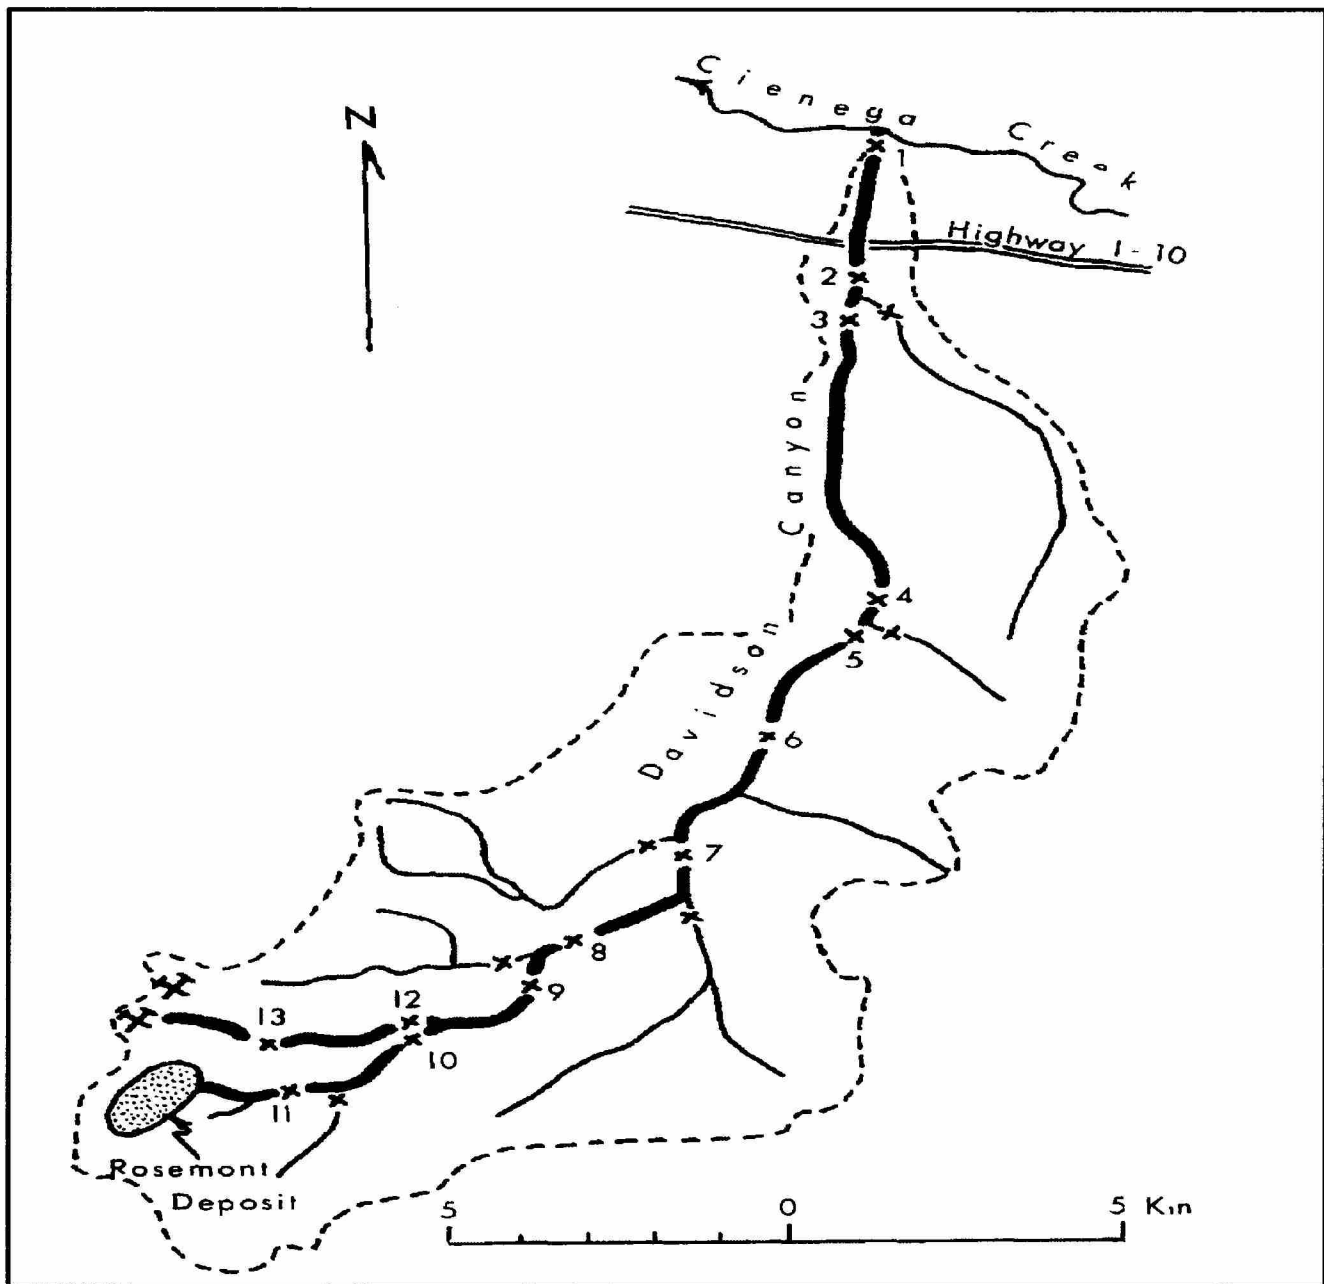
Figure 8. Sediment sampling locations in the Davidson watershed, from Hawkes (1976)

A paper from the Journal of Geochemical Exploration (Hawkes 1976) documents the sources of copper anomalies in sediments tributary to Cienega Creek (Figure 8 below, from Attachment 8). The anomalous values are identified as having sources in Barrel Canyon and "old copper prospects" in McCleary Canyon. These areas have been affected by many previous mine-related activities.

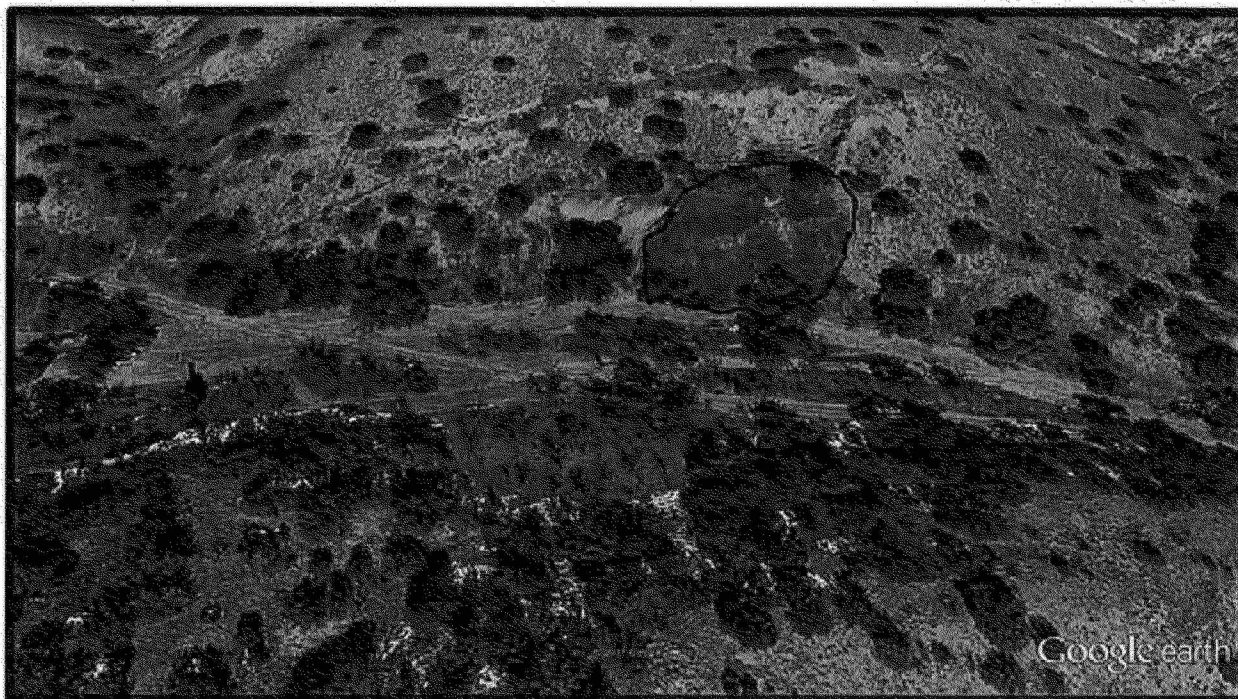
Figure 9. A photograph of the slag and former smelter site from Google Earth (outlined in black). Needs and opportunities for remediation of this site, which may be contributing to degraded water quality, have not been investigated.

A smelter operated along Wasp Canyon just upstream of its confluence with Barrel Canyon from 1879 to 1905, and was subsequently removed. (Tetra Tech 2009 in Appendix 8, and Figure 9 below) The smelter site is exempt from APP regulations per §A.R.S. 49-250(B)(11). The APP applicant proposes to cover the slag pile and remains of the smelter site with new, "dry" tailings. We are unaware of any further site investigation that has been required by state or federal authorities.
